Hi-tech fix for Ottawa main

Failure of a large-diameter water main in the Canadian capital resulted in the use of robotic inspection and monitoring systems, explains Lauren Rutherford

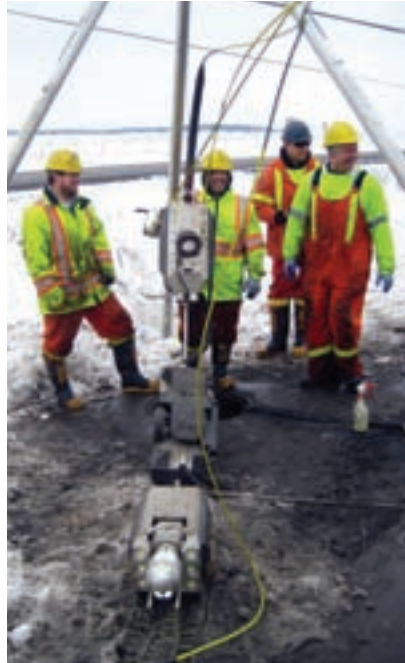
Crew ready to insert the robotic device into the water main

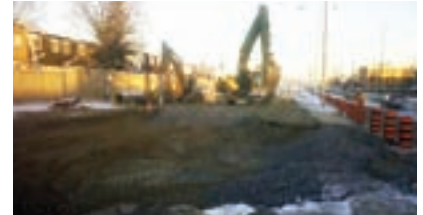
THE Woodroffe Avenue transmission main in Ottawa, Ontario, experienced a major failure in January, which opened a big hole across three traffic lanes, causing major disruption.

segment that failed, and the adjacent one, were experiencing chloride-induced corrosion of the pre-stressing wires and steel cylinder.

Crews working on the broken water main in Woodroffe Avenue in January

Once the Woodroffe Avenue pipeline was repaired, with a substantial section replaced, a SoundPrint AFO monitoring system was installed along 5km of the main to monitor the old sections and the newly replaced pipes in near real time. SoundPrint AFO is a patented, acoustic fibre-optic system for structural monitoring, and leak detection in both water and wastewater pre-stressed, concrete cylinder pipes.

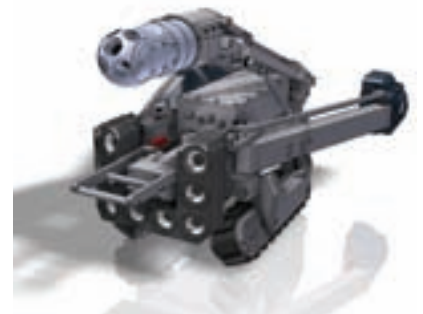
Manual inspections are a reliable method of detecting which pipes are in an advanced state of distress. This involved a Pure Technologies field team visually inspecting the pipe internally to identify where the rupture had occurred. Following this, an electromagnetic inspection using the PureRobotics device found that 41 of the 865 (4.7%) inspected segments were distressed.

Robotic device used to inspect the water main
