## **When to Intervene? Using Rates of Failure to Determine the Time to Shut Down Your PCCP Line.**

*Mike Wrigglesworth; Pure Technologies, 300-705 11<sup>th</sup> Ave SW, Calgary, AB, Canada, T2R 0E3; +1.403.266.6794*

*Michael S. Higgins, P.E.; Pure Technologies, 8920 State Route 108, Suite B; Columbia, MD 21042; 443-766-7873*

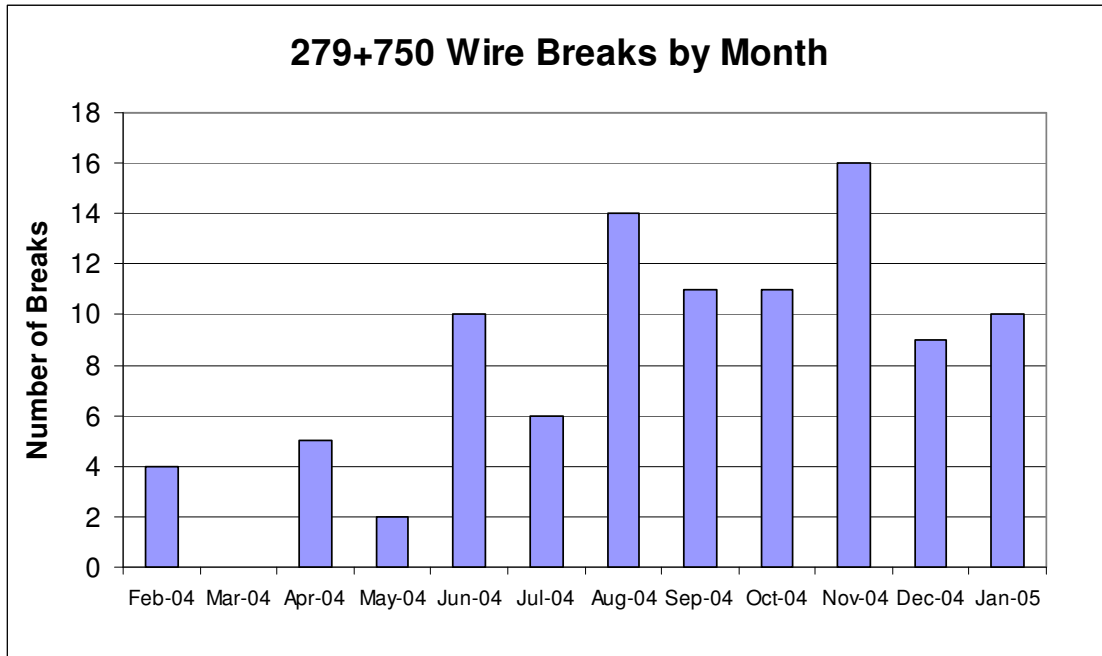
Figure 1: Wire breaks on pipe 279+750

A pipe section located at Station 279+750 on the TB line was not considered for replacement or repair based on results from the baseline condition assessment performed in 2001. An acoustic monitoring system was installed in December 2003 and wire breaks were almost immediately recorded on this pipe section. After one year of monitoring over 100 wire breaks had been recorded (Figure 4.1).

Based on this data, the pipeline was shutdown and the pipe section was repaired using external post-tensioning. Forensic investigations of the exposed pipe identified 148 wire breaks in the pipe section. Evaluating the rate of deterioration data for this pipe section was credited with preventing a likely rupture. Figure 5.1 shows photos of the pipe section exposed prior to its repair, divided by meter.

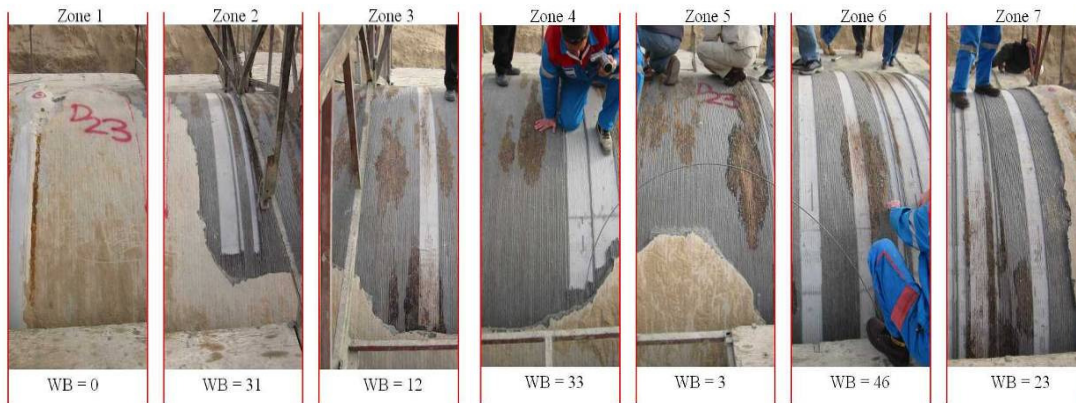
Figure 2: Photos of forensic investigation of pipe 279+750

It is likely that corrosion had started on this pipe when electromagnetic inspection was performed, but had not developed to the point of significant wire break damage. However, within three years, the rate of wire break damage increased significantly.

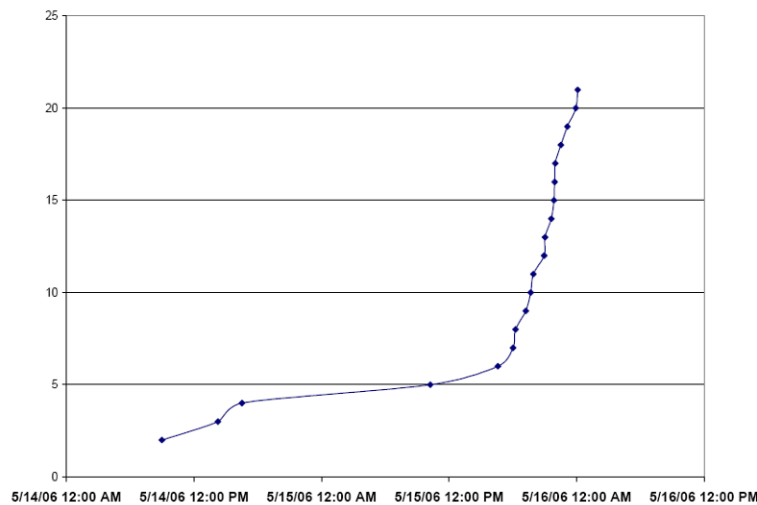
Figure 3: San Diego County Water Authority wire breaks leading up to failure

This pipe section was estimated to have 15 wire breaks during an internal electromagnetic inspection. Acoustic monitoring of the pipe section was performed following returning the pipe to service. Within a month of pressurizing the pipe, a series of wire breaks were detected by the acoustic monitoring system. Slow communications impeded data transmission and timely notification of these events and the pipe section failed in close proximity to a joint. This failure provides information on the rate of failure immediately prior to a rupture. In the week leading up to the rupture, 21 wire breaks (rate= 91 wire breaks per month) were recorded. In the day prior to the failure, 17 wire breaks were recorded. A plot displaying the wire breaks detected by the acoustic monitoring system is shown in Figure 3.

- The case studies above demonstrate that rate of wire break activity can be used to predict the general condition of a PCCP pipe section.
- A wire break rate of 91 wire breaks per month was observed prior to the San Diego County Water Authority failure. This wire break rate is obviously indicative of a pipe near or in a state of failure.

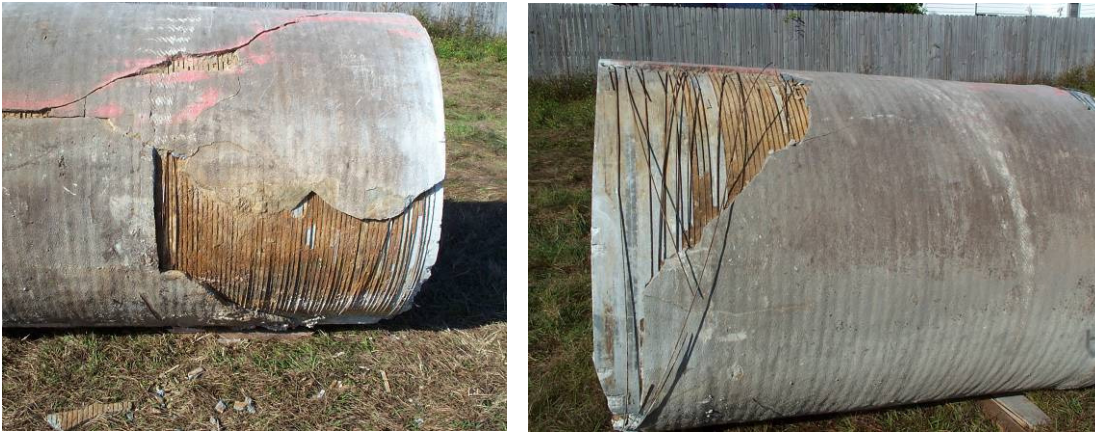
Figure 4: Pinellas County pipe sections

The Belcher Road PCCP transmission main is approximately 3 miles long and is situated under a major roadway. Acoustic monitoring of this pipe section was performed on the pipeline for a total of 133 days. Wire breaks were detected on 119 pipe sections during the monitoring period. The quantity of wire breaks on each pipe section ranged from one wire break to 54 wire breaks, making the rate of wire breaks on the pipeline ranging from 0 to 12 wire breaks per month. Pipes sections with high rates of deterioration were subsequently to confirm the wire break damage and repaired. Photos from these pipe section are shown in Figure 4.

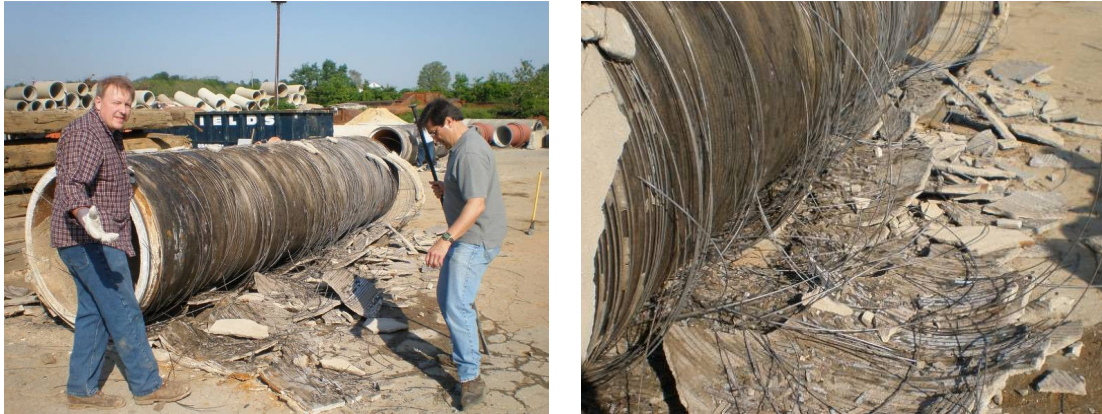
Figure 5: Ridge road main in Howard County

The 42-inch PCCP main in Howard County, MD was acoustically monitored three times to determine rate of deterioration. The duration of monitoring for each of these times was 119 days, 551 days, and 520 days in 2000, 2004 to 2005, and 2006 to 2007 respectively. One pipe section was detected to have on going wire break activity in each of these monitoring periods. The rates of deterioration were measured to be 3.5 wire breaks per month, 0.9 wire breaks per month, and 0.6 wire breaks per month respectively. This pipe section was excavated in late 2006 to implement repair

strategies. Upon excavation and forensic evaluation, nearly every wire wrap on this pipe section was broken (see Figure 5).

It is believed that the reason the pipe had not failed was that the principal deterioration mechanism was hydrogen embrittlement induced cracking of the prestressing wire. This resulted in numerous broken wire wraps, but the position of the breaks were dispersed around the circumference, which reduces the structural significance of the wire breaks compared to corrosion induced wire breaks where the damage is usually contiguous.

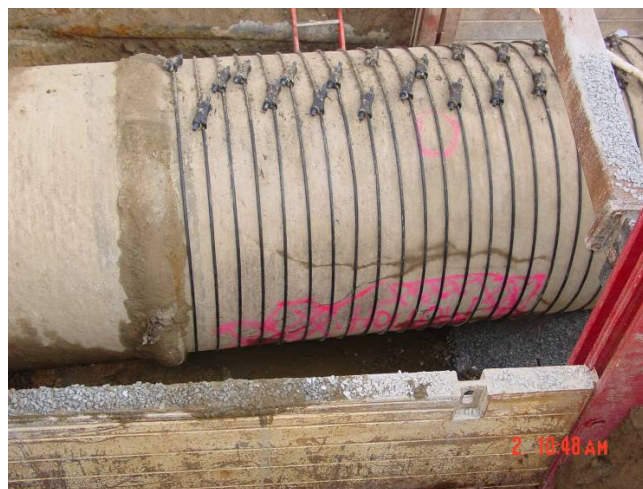
Figure 6: GLSD Pipe Section 22

Pipe Section #22 of a 72-inch PCCP main was acoustically monitored for 260 days during which 14 wire breaks were recorded, a rate of 0.6 wire breaks per month. Afterwards the pipe was excavated and a large area of mortar delamination and cracking was observed on the springline of the pipe section. The pipe was strengthened with post tensioning tendons (see Figure 6).

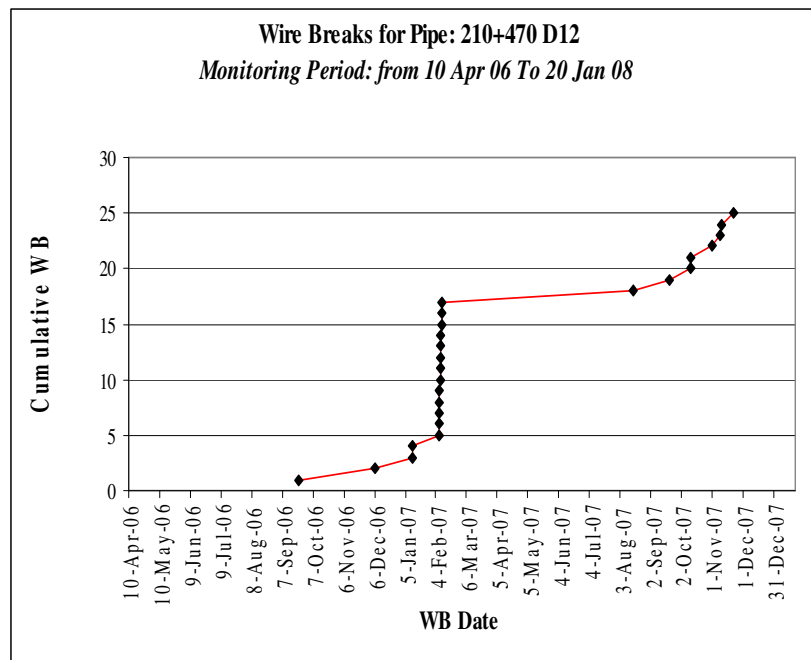
Figure 7: Non-Linear Wire Break Activity at Pipe 210+470 D12

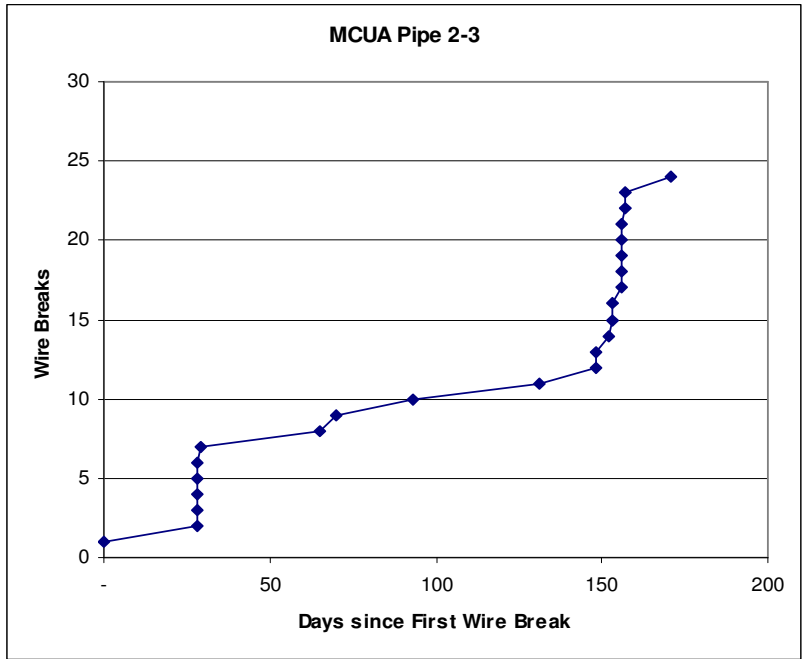
Figure 8: Non-Linear Wire Break Activity at MCUA Pipe 2-3

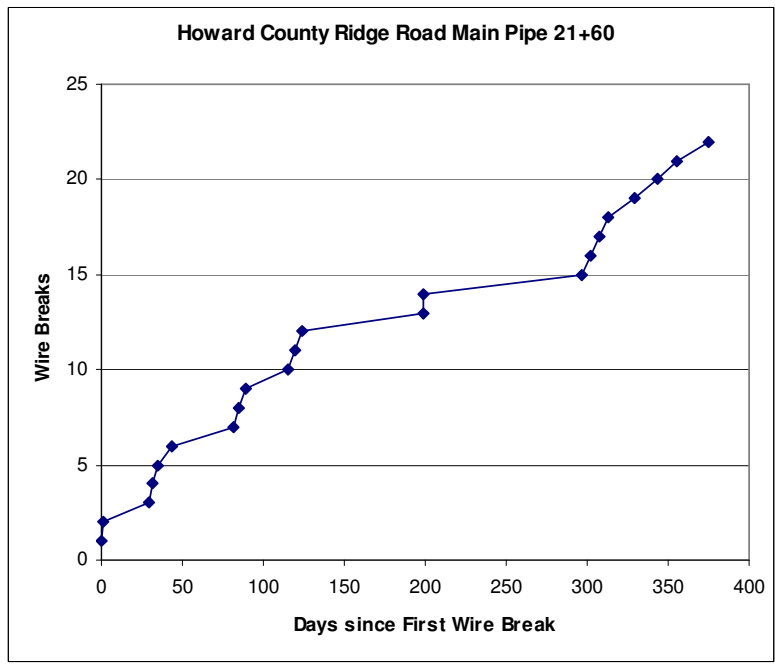
Figure 9: Non-Linear Wire Break Activity at Howard County Pipe 21+60

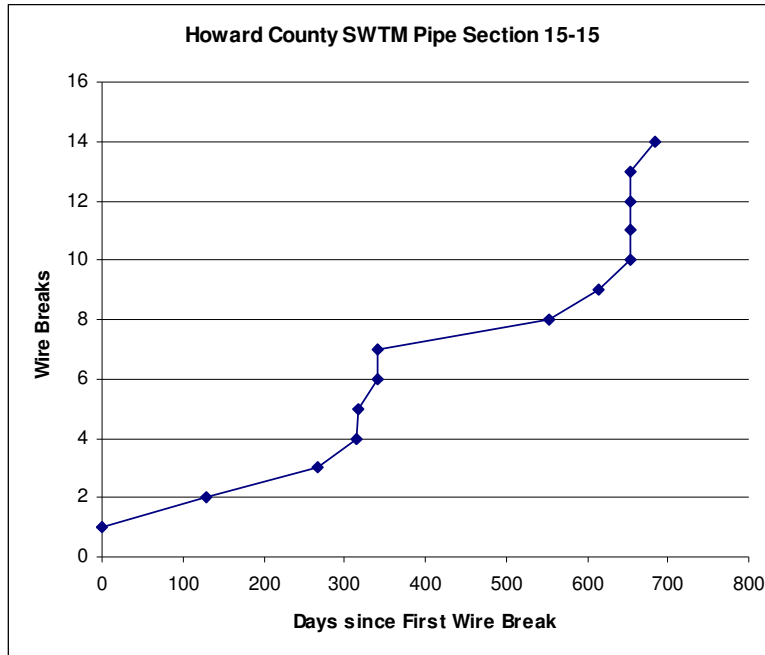
Figure 10: Non-Linear Wire Break Activity at Howard County Pipe 15-15

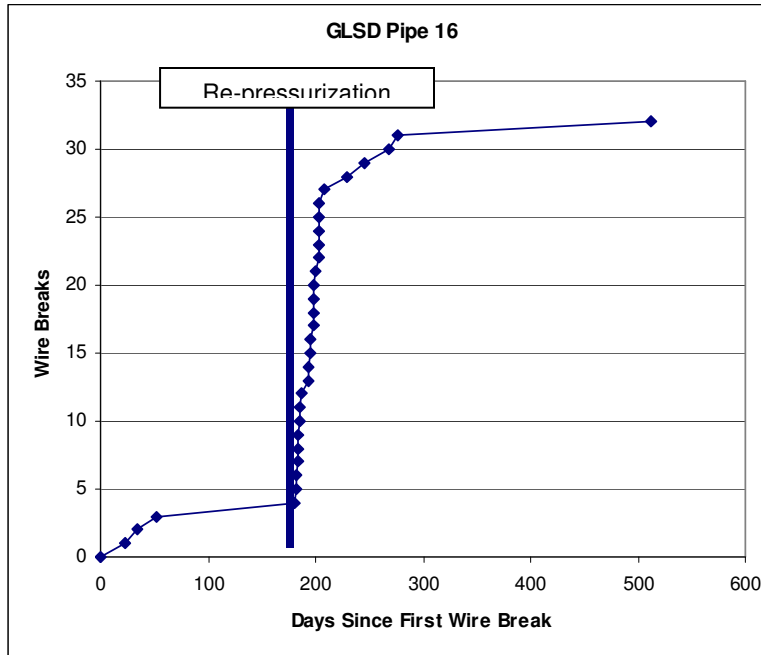
Figure 11 shows an example of a pipe that experienced an increased rate of wire break activity during pressurization.

Figure 11: GLSD wire breaks observed following re-pressurization
